DEPARTMENT OF TRANSPORTATION

Contract #: 04-0120F4Cty: SF/ALA Rte: 80 PM: 13.2/13.9File #: 69.28**WELDING INSPECTION REPORT****Resident Engineer:** Pursell, Gary**Address:** 333 Burma Road**City:** Oakland, CA 94607**Report No:** WIR-001780**Date Inspected:** 21-Mar-2008**Project Name:** SAS Superstructure**OSM Arrival Time:** 600**Prime Contractor:** American Bridge/Fluor Enterprises, a JV**OSM Departure Time:** 1800**Contractor:** Zhenhua Port Machinery Company, Ltd (ZPMC), Changxing Island **Location:** Shanghai, China**CWI Name:** Chen Xi and Chen Chih-Ming**CWI Present:** Yes No**Inspected CWI report:** Yes No N/A**Rod Oven in Use:** Yes No N/A**Electrode to specification:** Yes No N/A**Weld Procedures Followed:** Yes No N/A**Qualified Welders:** Yes No N/A**Verified Joint Fit-up:** Yes No N/A**Approved Drawings:** Yes No N/A**Approved WPS:** Yes No N/A**Delayed / Cancelled:** Yes No N/A**Bridge No:** 34-0006**Component:** OBG side and deck panels**Summary of Items Observed:**

On this day CALTRANS OSM Quality Assurance Inspector (QA) Steve Hall was present During the times noted above for observations relative to the fabrication of the SAS Superstructure being performed by Z

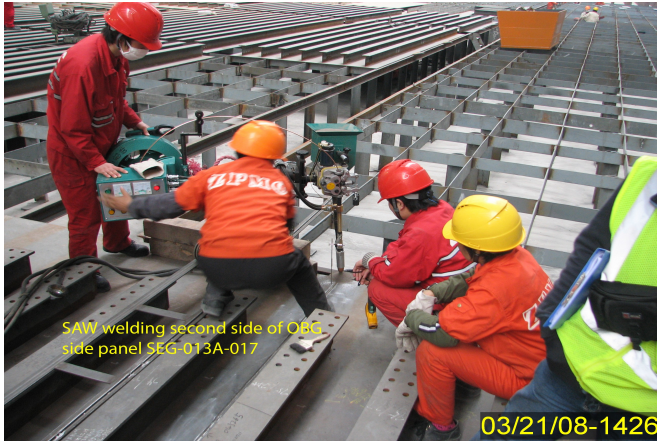
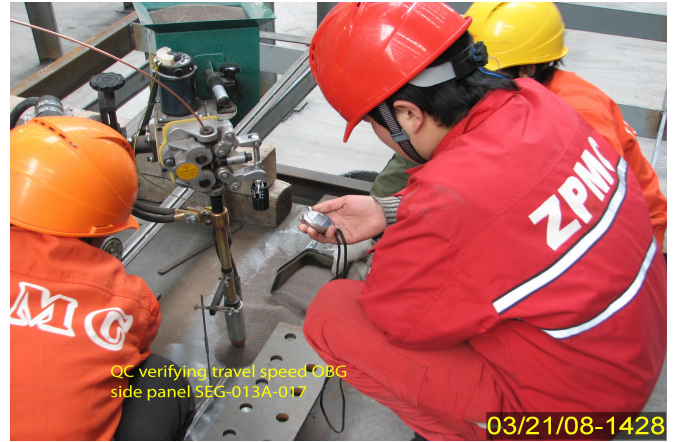
After the completion of the PMT QA observed ZPMC qualified welding personnel perform the GMAW welds joining the closed U-Ribs to deck panel DP-137-001. NOTE: QA observed ZPMC welding personnel started welding deck panel DP-137-001 before Caltrans QA Ultrasonic Testing (UT) technician was finished with UT depth of penetration testing. QA observed four ZPMC QC inspectors in the vicinity of the welding operations including ZPMC CWI identified as Sun Wei. There were also nine American Bridge/Fluor (ABF) inspectors in the area as well.

QA observed ZPMC qualified welding personnel perform Submerged Arc Welding (SAW) on the second side of the Complete Joint Penetration (CJP) panel splice joint for panel #seg-013A-017. QA observed two ZPMC Quality Control (QC) personnel including CWI identified as Chen Chih-Ming in the vicinity of the welding along with four American Bridge/Fluor (ABF) Quality Control representatives. QA observed ZPMC QC verify preheat and welding parameters. The preheat and welding parameters appeared to be in compliance with the posted WPS's and are as follows:
